Degradation of polypropylene in the human eye: A sem-study

W.L. JONGEBLOED¹ and J.F.G. WORST²

¹ Centre for Medical Electron Microscopy, University of Groningen, 69/2 Oostersingel, 9713 EZ Groningen; ² Eye Physician and Surgeon, 11 Julianalaan, Haren, The Netherlands

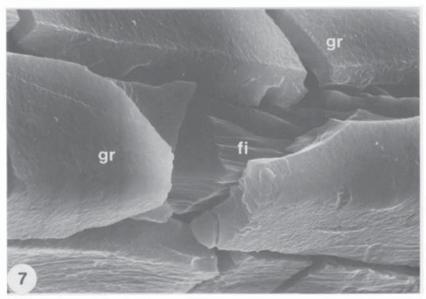
Figures 6 and 7 represent details of Figures 3 and 4 respectively, showing the subsurface layer after splitting off of the lumps of the surface layer. The subsurface layer shows a fibrillar character and the splitting off

of the surface layer is clearly observable. The outside of the lumps of the surface layer is covered with a thin layer of organic material with a slightly granular appearance.

Figure 6. Detail of Figure 3 showing subsurface layer with fibrillar character (fi); note thin organic deposit with granular character (gr) on outside of lumps of surface layer. Magn. $2000 \times$.

Figure 7. Detail of Figure 4 showing splitting of surface layer from underlying layer with fibrillar appearance (fi); lumps covered with somewhat granular material (gr). Magn. $2000 \times$.

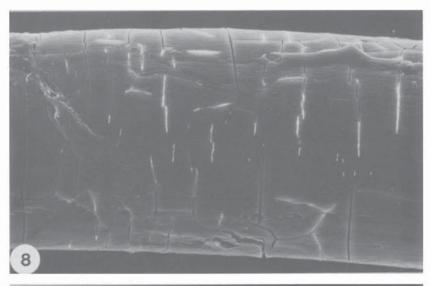
Figure 8 represents the central part of the suture, some cracks in the surface are already visible and some deposition of material. The diameter

still has its original value of 200 μ m. Figures 9–13 represent sections of the right side of the suture of Figure 1.

Figure 8. Central part of suture of Figure 1, which was not in contact with tissue. Some cracking of surface layer present; diameter 200 μ m. Magn. 300 \times .

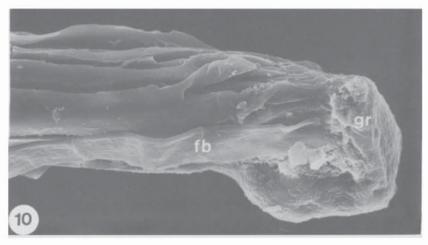
Figure 9 shows the irregular diameter and the splitting off of parts of the surface layer, at low magnification.

Figure 9. Part of right side of suture of Figure 1 at low magnification showing irregular diameter and cracking of surface layer. Magn. $120\times$.

Figure 10. Spontaneously broken end of suture of Figure 1 showing granular deposit (gr) and fibre-like material (fb) at the tip. Magn. $600\times$.

The spontaneously broken-off end of the suture, the actual reason for removal from the eye, is shown in Figure 10. The end of the surface is covered with slightly granular material and rather long strands of fibrillar material.

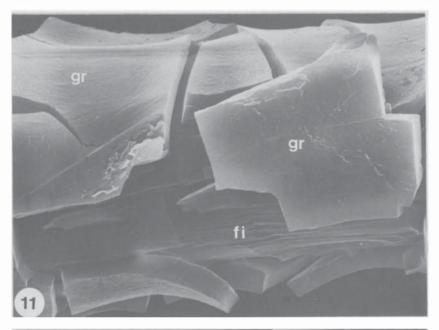
Figure 11 shows the destruction of the polypropylene in a rather dramatic way; the complete surface layer has broken into pieces, exposing the subsurface layer. The outside layer is covered with some deposits, mainly of a granular nature.

Figure 11. Part of right side of suture of Figure 1 showing almost complete degradation of surface layer, large lumps have detached exposing subsurface layer with fibrillar character (fi). Note granular deposit on lumps (gr). Magn. $975 \times$.

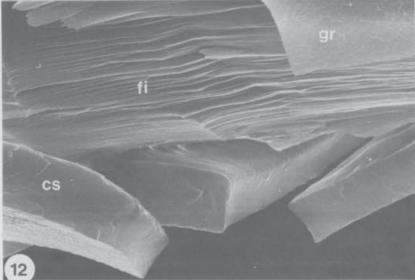
The subsurface layer is observable in more detail in Figure 12 (detail of Figure 11); the fibrillar character of this layer is clearly visible, while the splitting of the surface layer is noticeable, particularly at the cross-sections of the split-off lumps in the lower part of the picture.

Figure 12. Detail of Figure 11 showing subsurface layer (fi) and split-off lumps of surface layer in more detail (cs). Magn. $2500 \times$.

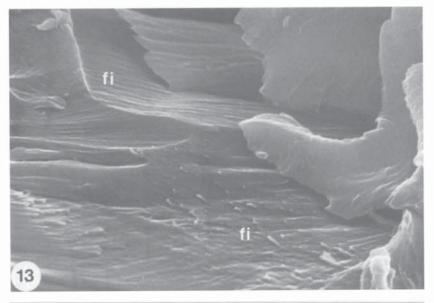
The fibrillar character of the subsurface layer, and the irregular splitting of the surface layer from the underlying layer as the result of a chemical change in the surface layer, are shown in more detail in Figure 13.

Figure 13. High magnification of subsurface layer after detachment of surface layer; note irregular splitting effect due to chemical change in polypropylene. Fibrillar character (fi) of subsurface layer clearly observable. Magn. $5000 \times$.

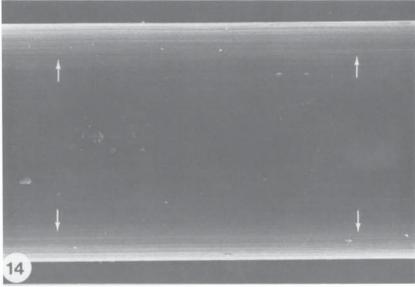
In a virgin piece of surgical polypropylene, taken from an intact package, none of the phenomena described above are observable (Figure 14). The diameter is $200 \,\mu\text{m}$ and only thin grooves due to the manufacturing process are visible running along a very smooth surface (arrows).

Figure 14. Virgin piece of polypropylene from a surgical packet, prepared for SEM in exactly the same way as the suture of Figure 1, showing no degradation at all; note manufacturing grooves (arrows). Magn. $300\times$.
